Impact damage detection on composites using optical NDT techniques

Jasson Gryzagoridis, Dirk Findeis
Mechanical Engineering Department
University of Cape Town, South Africa.
Phone: +27 21 6503229
Fax: +27 21 6503240
E-mail: jasson.gryzagoridis@uct.ac.za

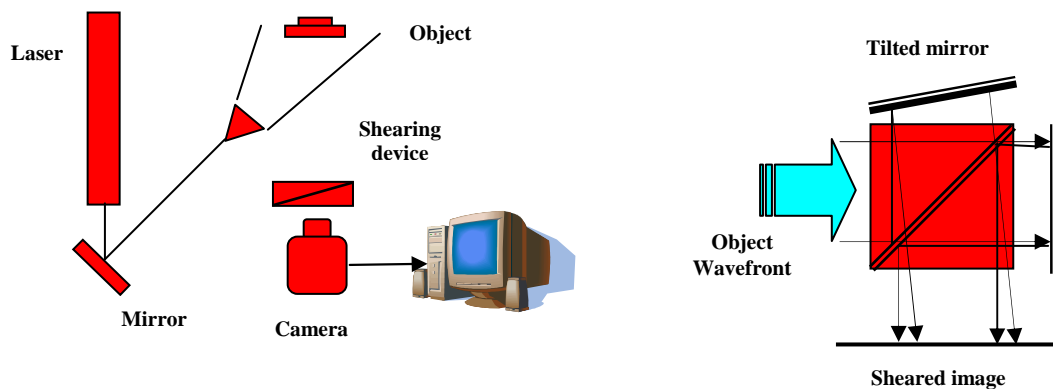
Digital Shearography has its origins firstly as a strain measurement technique (1974) and later as a non-destructive testing tool (1982) as reported by Hung ^(3, 4). Digital Shearography as a non-contacting, whole field view and practically real time technique, is capable of revealing sub surface defects as a localized disturbance in the fringe pattern depicting the gradient of out-of-plane surface displacements on the component under test. In response to a mild perturbation of the specimen under test by mechanical, thermal, pressure or vibratory means the surface of the test piece which is illuminated with a laser changes its speckled image. The subtraction of two speckled images of the object's surface, obtained one before and the other after the perturbation, results in the fringe pattern which resembles zebra stripes superimposed on the object's image. “The anomalies in the fringe pattern, basically display the position and approximate size of the defect, however not its depth relative to the surface”⁽⁵⁾. Typical Digital Shearographic NDT set-ups, similar to the one depicted in figure 1(left), include a personal computer equipped with software to process the images of the object under test. A single wavelength light source (a laser) is used to illuminate the object thus producing a unique speckled image. The images are obtained via a digital camera viewing the object through some shearing optics and are stored in the pc's image digitizer. A typical shearing device (favoured by the authors as it is used in their portable shearography system⁽⁴⁾), is the modified Michelson interferometer as illustrated in figure 1(right).

Figure 1. Typical Shearography set-up (left) and image shearing device (right)

It can be shown that measurements of the gradient of the normal displacement of points on a given surface (along a given direction) can be effected using the following equation

$$\frac{\partial \delta}{\partial x} = \frac{\lambda N}{2S} \quad (1)$$

where $\frac{\partial \delta}{\partial x}$ is the displacement gradient along the x axis (in this case or y axis or any chosen direction), λ is the wave length of the laser, N is the number of fringes observed, and S is the lateral shear imposed by the image shearing device.

When one compares the set-ups of Digital Shearography and ESPI (figures 1 and 2 respectively) the similarity is apparent, with the major difference being the reference beam. For example the reference beam in the Shearography set-up is generated by the actual surface of the test piece and therefore it carries the signals of the body motion. This of course is highly desirable in Shearography because it reduces the effect of environmental disturbances that de-correlate the speckle images. In the ESPI set-up the reference beam is produced from the original illumination beam and without being disturbed is combined with the beam reflected from the object by a beam splitter located after the camera’s lens. It appears therefore that if a reference beam can be introduced in the shearography set-up and combined with the image of the object under test we would obtain an ESPI result. This is relatively easily accomplished by introducing in say one third of the illumination field of the object an optically diffuse flat surface. The surface will reflect its image onto the beam splitter where it would combine with the reflected image of the surface under test and create the fringe pattern that exhibits displacements normal to the surface. What has been described above is depicted in figure 3 where we note that the shear distance is substantially increased (by the tilting of one of the mirrors) to and beyond the point that the two images share no common portion. Under these conditions with the reference beam generated by the neutral surface, one image (the lower one in fig. 3 or the one transmitted through the beam splitter) of the portion of the surface under test is combined with the reference beam creating ESPI conditions.

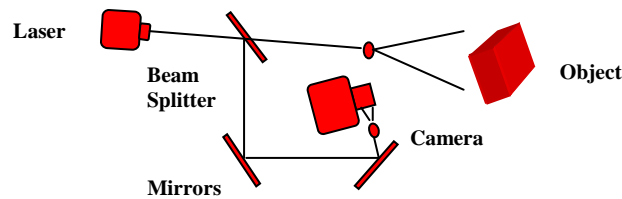
Figure 2. Typical ESPI set-up for out-of-plane displacement measurement

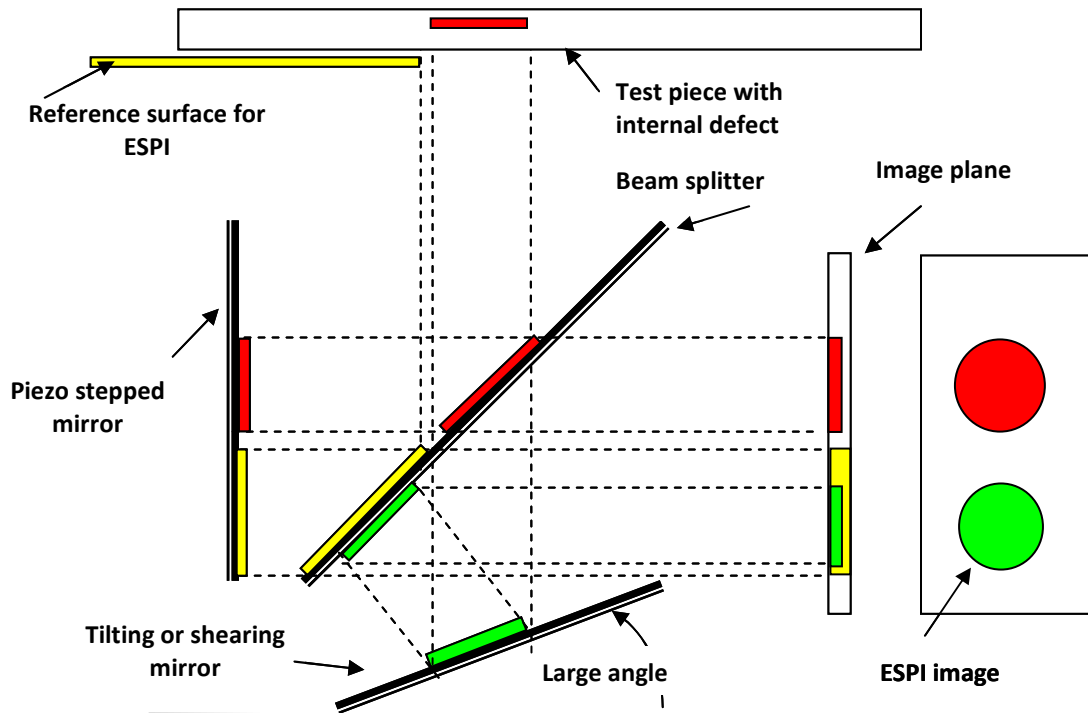
Figure 3. Transformation of Shearography to ESPI

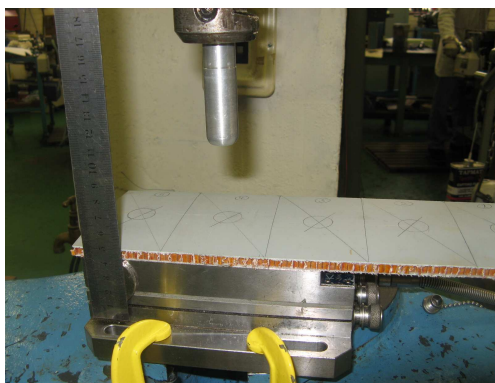
Figure 4. Left, setup used to create the impact damage on the specimen with typical core damage obtained as depicted in the image to the right.

Figure 4 shows a steel rule vertically positioned to measure the heights from which impact damage was to be initiated. The impactor head was hemispherical, made from an

aluminium bar 20 mm in diameter which was guided to fall on the specimen that rested on the tool dynamometer. The output (Newtons) of the tool dynamometer was read off an oscilloscope together with the impact time. Thus the experimental impulse could be found and compared to the theoretical impulse values however, for the purpose here being a comparative exercise, we will not require these calculations and results. The defects were created accordingly by releasing the impactor from different heights. Care was taken to ensure that the impactor was released from heights that did not result in creating visible damage to the surface of the specimen. (cracks, indentations, scratches etc.) Typical phased stepped shearographic results obtained by mildly heating the specimen are depicted in figure 5 below; impacts for this specimen were accomplished from heights of 200, 150 and 100 mm respectively starting from the left of the image.

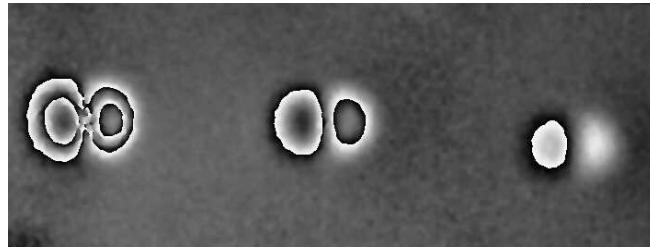
Figure 5. Internal impact damage revealed with Shearography

The same specimen as depicted in figure 5 was examined using the IRISYS-1011 Universal Thermal Imager after the specimen was heated mildly using a hair dryer for a few seconds. The results as depicted in figure 6, were obtained with a little effort by continuously manipulating the sensitivity of the infrared camera, are comparable to those obtained with the shearographic system.

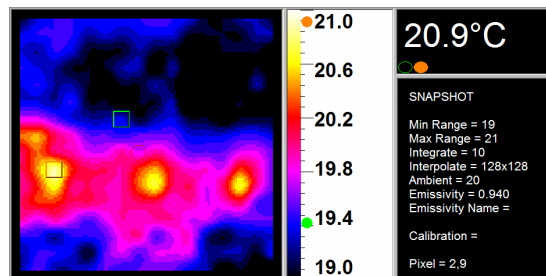
Figure 6. Internal impact damage revealed with Thermography

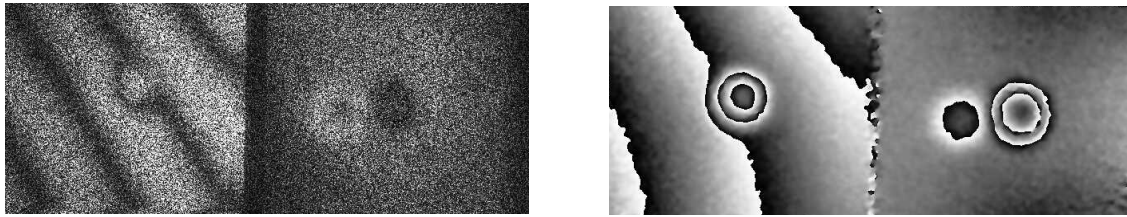
Continuing with the same specimen and concentrating on the middle of the three impacts that were simulated on the UAV's wing composite specimen, the position was examined for signs of internal damage by using UCT's Shearography system in the ESPI mode. The result which is shown in figure 7 below is as dramatic as those obtained in the Shearographic mode (see figure 5 above). The image on the left for both assemblies is in ESPI format, the first as an intensity image and the second as a filtered stepped phase interferogram and the ones on their right are their respective Shearography counterparts. The fringes that appear at an angle in the ESPI images are indication of body motion to which ESPI is very susceptible. They were probably

caused by the motion of the specimen itself, rather than motion of the reference surface that was placed quite securely and rigidly in front of the test piece.

Figure 7. Internal impact damage (middle of the three) revealed with ESPI intensity image on the left and filtered stepped phase image on the right

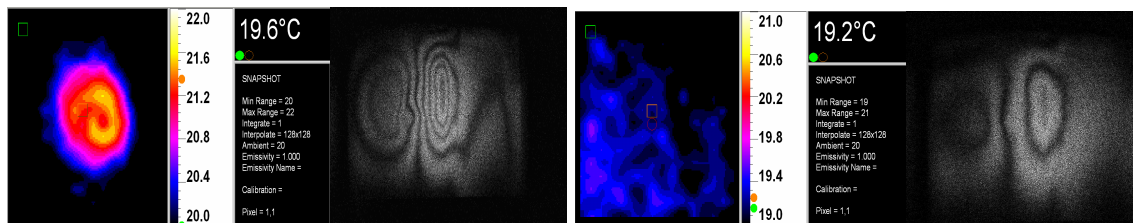
Finally the tests indicated that at all times Shearography continued to reveal the internal damage due to impact for a longer period compared to the Thermographic technique. This is demonstrated in the images depicted in figure 8 below.

Figure 8. The Shearographic system continued to indicate the presence of a defect long after the Thermographic technique

strength of the skin. However, when slightly loaded it was noticed that the core easily compressed and the specimen was a great deal weaker in the impact region. The lack of delamination at the skin-core interface does not agree with previous held conviction. What may in fact be happening is that an imperceptible dent has occurred and when the specimen is thermally loaded the skin flexes outwards against the weakened or crushed core much in the same way as if a delamination existed. The results presented in figures 5, 6, 7 and 8 clearly demonstrate that all three techniques, that is, IRT, Shearography and ESPI, detect and show readily the location of defects in the composite material tested. Moreover, the IRT images were not only indicating the position of the defect or flaw, but produced data concerning the temperature of the region of the defect in relation to the cooler surrounding material. The Shearographic system however, was exceptional in the display of the results. The system was not just more sensitive compared to IRT in responding to the heating stimulus on the specimens and readily displayed the image denoting the defect, but was also able to show the image for much longer period of time than the IRT system. In all the test results obtained, both the Shearographic and ESPI systems continued to show live fringes while the IRT system had lost the 'hot spot'. This effect can be explained quite simply; as the specimen's surface cools it is very probable that below the skin the temperature around the defect is still higher than equilibrium thus straining the body which obviously affects or strains the skin surface as well, hence the surface is still strained although its temperature has reached equilibrium with the environment.
